SMITTYBILT TECHNICAL UPDATE

APPLICATION 2007+ JK

PART NO. 2793

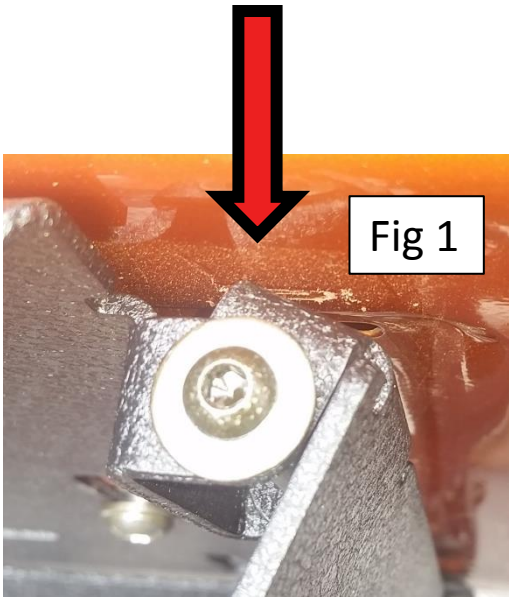
Depending on positioning of table, side brackets may slightly come into contact with tailgate if mounted on the inside of the tailgate.

Short term fix: use M12 or ½" flat washer(qty 4) as spacer between tailgate and table.
