# SMITTYBILT TECHNICAL UPDATE

## TECHNICAL ISSUE

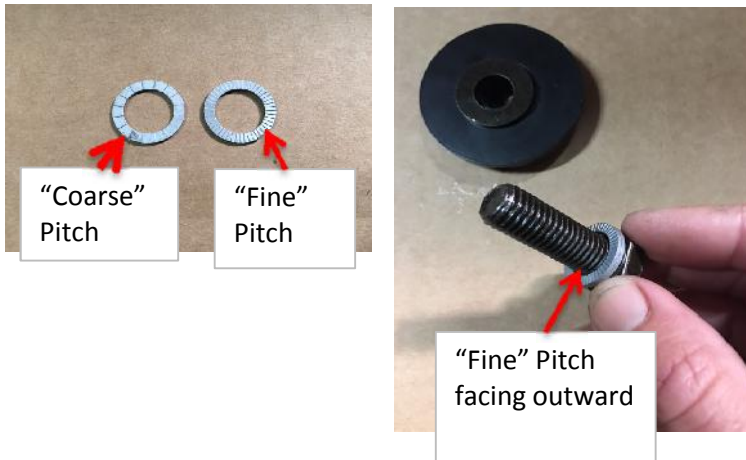
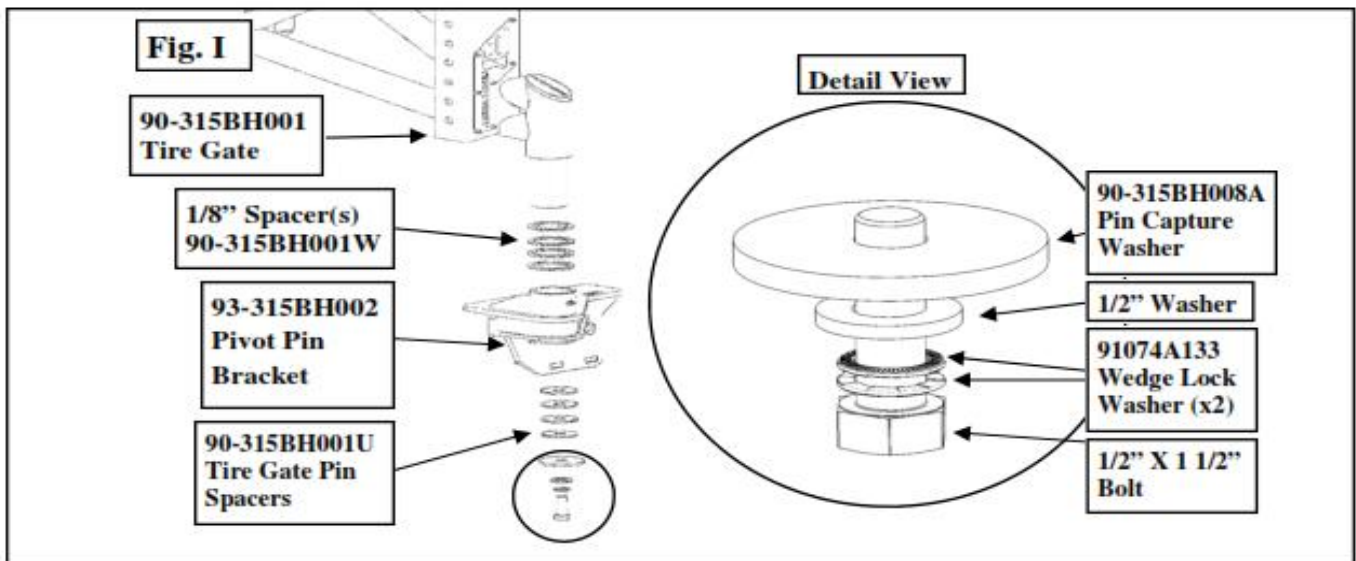
The bolt securing the pivot pin may come loose.

Re-install pivot pin bolt using Nord Lock washers. (Shown Below) This will prevent the bolt from "backing-out"  
Current inventory now includes these.

**Note:** Nord Lock Washers need to be installed with the “coarse” pitch sides facing inward towards each other and the “fine” pitch sides facing outward.
